Ohio Department of Natural Resources Division of Soil and Water Resources Fact Sheet

Fact Sheet 99-52

Dam Safety: Upstream Slope Protection

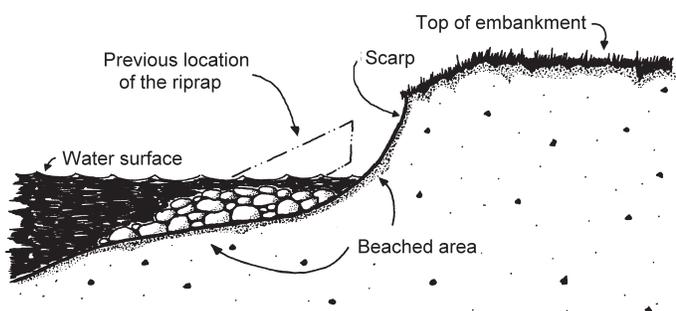
Figure 1 - Beaching

The repeated action of waves striking the embankment surface erodes fill material and displaces it farther down the slope, creating a “beach.” The amount of erosion depends on the predominant wind direction, the orientation of the dam, the steepness of the slope, water level fluctuations, boating activities, and other factors. Further erosion can lead to cracking and sloughing of the slope which can extend into the crest, reducing its width. When erosion occurs and beaching develops on the upstream slope of a dam, repairs should be made as soon as possible. However, an erosion scarp less than 1 foot high may be stable and not require repair.

Slope protection is usually needed to protect the upstream slope against erosion due to wave action. Without proper slope protection, a serious erosion problem known as “beaching” can develop on the upstream slope.

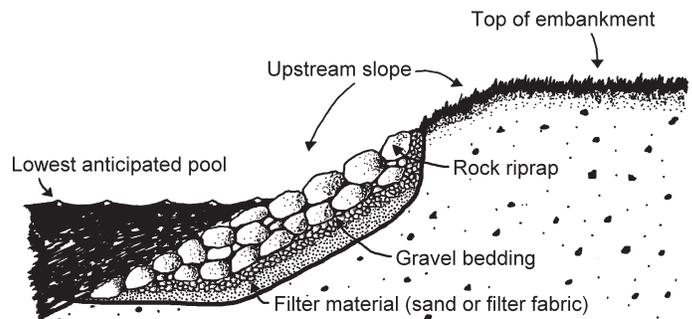
Figure 2 - Rock Riprap

Rock riprap consists of a heterogeneous mixture of irregular shaped rocks placed over gravel bedding and a sand filter or geotextile fabric. The smaller rocks help to fill the spaces between the larger pieces forming an interlocking mass. The filter prevents soil particles on the embankment surface from being washed out through the spaces (or voids) between the rocks. The maximum rock

size and weight must be large enough to break up the energy of the maximum anticipated wave action and hold the smaller stones in place. If the rock size is too small, it will eventually be displaced and washed away by wave action. If the riprap is sparse or if the filter or bedding material is too small, the filter material will wash out easily, allowing the embankment material to erode. Once the erosion has started, beaching will develop if remedial measures are not taken. Technical Release No. 69 developed by the USDA, Natural Resources Conservation Service can be used to help design engineers develop a preliminary or detailed design for riprap slope protection.

The dam owner should expect some deterioration (weathering) of riprap. Freezing and thawing, wetting and drying, abrasive wave action, and other natural processes will eventually break down the riprap. Its useful life varies with the characteristics of the stone used. Stone for riprap should be rock that is dense and well cemented. In Ohio, glacial cobbles or boulders, most limestone, and a few types of sandstone are acceptable for riprap. Most sandstones and shales found in Ohio do not provide long-term protection. Due to the high initial cost of rock riprap, its durability should be determined by appropriate testing procedures prior to installation. Vegetative growth within the slope protection is undesirable because it can displace stone and disturb the filter material. Heavy undergrowth prevents an adequate inspection of the upstream slope and may hide potential problems. For additional information, see the “Trees and Brush” fact sheet.

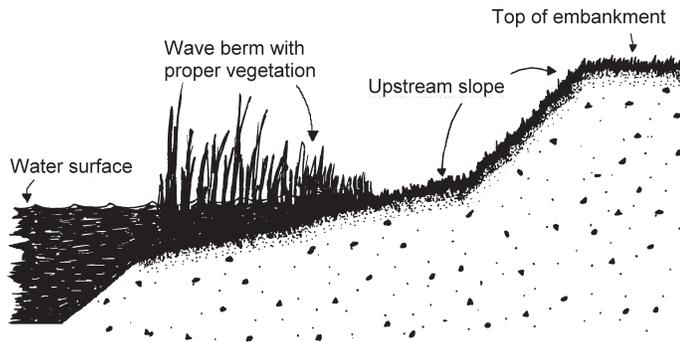
Figure 3 - Vegetated wave berm

Vegetated wave berms dissipate wave energy and protect the slope from erosion. Berms are constructed on the upstream slope at the normal pool level and should be no less than 20 feet wide. This method of slope protection will not work well where the water surface fluctuates regularly from normal pool. If improper or sparse vegetation is present, the wave berm may not adequately dissipate the wave energy, allowing erosion and beaching to develop on the upstream slope. Technical Release No. 56 developed by the USDA, Natural Resources Conservation Service provides design and layout information.

The vegetation on the wave berm should be monitored regularly to verify adequate growth. Sufficient funds should be allocated for the regular maintenance of the vegetation. Severe erosion or reoccurring problems may require a registered professional engineer to design a more effective slope protection.

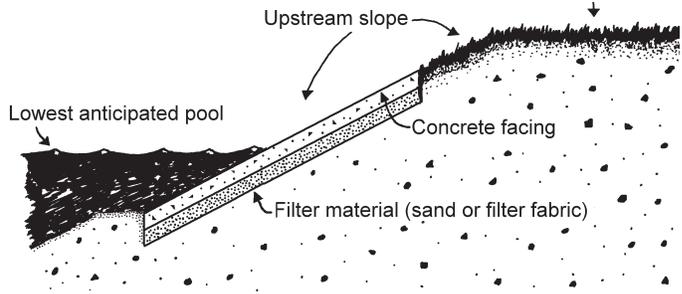
Figure 4 - Concrete facing

Concrete facing can be used if severe wave action is anticipated, however, settlement of the embankment must be insignificant to insure adequate support for the concrete facing. A properly designed and constructed concrete facing can be expensive. This slope protection should extend several feet above and below the normal pool level. It should terminate on a berm or against a concrete curb or header. Granular filter or filter fabric (geotextile) is required under the concrete facing to help reduce the risk of undermining.

As with any type of slope protection, problems will develop if the concrete facing has not been properly designed or installed. Concrete facing often fails because the wave action washes soil particles from beneath the slabs through joints and cracks. This process is known as undermining, which will continue until large voids are created. Detection of voids is difficult because the voids are hidden. Failure of the concrete facing may be sudden and extensive. Concrete facing should be monitored for cracks and open joints. Open joints should be sealed with plastic fillers and cracks should be grouted and sealed. For additional information, see the “Problems with Concrete Materials” fact sheet.
