Ohio Department of Natural Resources
Division of Soil and Water Resources
Fact Sheet

Fact Sheet 99-54

Dam Safety: Ground Cover

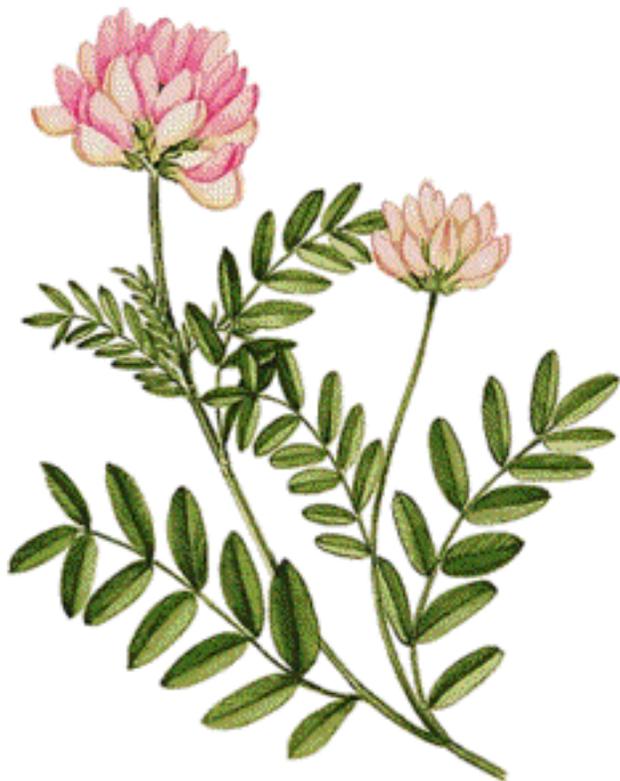
Crown vetch, a perennial plant with small pink flowers, has been used on some dams in Ohio but is not recommended (see Figure 1). It hides the embankment surface, preventing early detection of cracks and erosion. It is not effective in preventing erosion.

Figure 1: Crown Vetch
(Source: <http://www.vg.com>)

Vines and woody vegetation such as trees and brush also hide the embankment surface preventing early detection of cracks and erosion. Tall vegetation also provides a habitat for burrowing animals. All improper vegetation must be removed from the entire embankment surface. Any residual roots that are larger than 3 inches in diameter must be removed. All roots should be removed down to a depth of at least 6 inches and replaced with a compacted clay material; then 4 inches of topsoil should be placed on the disturbed areas of the slope. Finally, these areas must be seeded and mulched to establish a proper grass cover.
